Tree Survey: Trees in Westfield Village.

Client: Westfield Parish Council.

Date: January 2025

Surveyors and Report Authors: F. Nowne BA (Hons.)

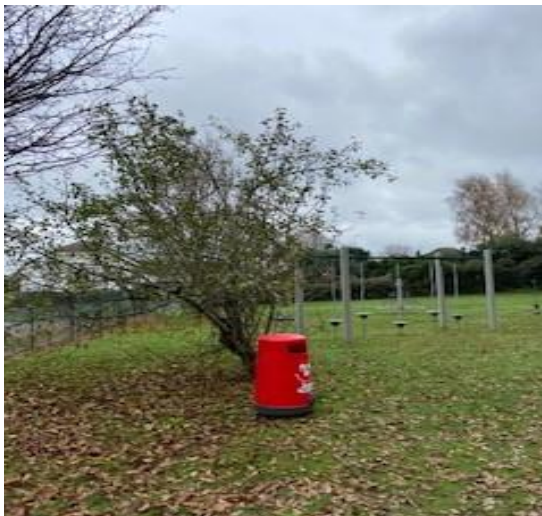
Tree	Species	Life Stage	Condition	Height & Dbh	Comments
T1	Crab Apple	M	<p>Well balanced crown, starting to exhibit veteran features. Height to lowest part of canopy = 1.8m. Open unions, no tight forks.</p> <p>Crown spread: N 2 m, E 2 m, S 2.5 m, W 2 m.</p> <p>Multi-stemmed from 2m exhibiting tight junction points and some in-growing limbs.</p> <p>Good ground conditions on observation</p> <p>Minor mechanical damage to southern side of main stem.</p> <p>Some honey fungus growth at the base of the stem.</p> <p>2021 – wound on main stem exhibits further decay – fruiting body of honey fungus on the ground within the root zone area. Cyclical reduction recommended in 2020 not carried out to date. Consider reduction.</p> <p>2023 – wound to main stem is struggling to heal. Consider reducing crown by 30%.</p>

T1 Mechanical damage at base and fruiting bodies – Crab Apple

<p>7 m</p> <p>270 mm</p>	<p>Footpath to the north – soil levels have been altered in the past.</p> <p>Recommend remove of small amount of deadwood within the canopy over target areas.</p> <p>Due to amenity area recommend cyclical reduction plan, to maintain at current size – within five years carry out light sympathetic reduction to BS 3998.</p> <p>Monitor fungal growth each year.</p> <p>Provides good nesting and roosting habitat.</p>

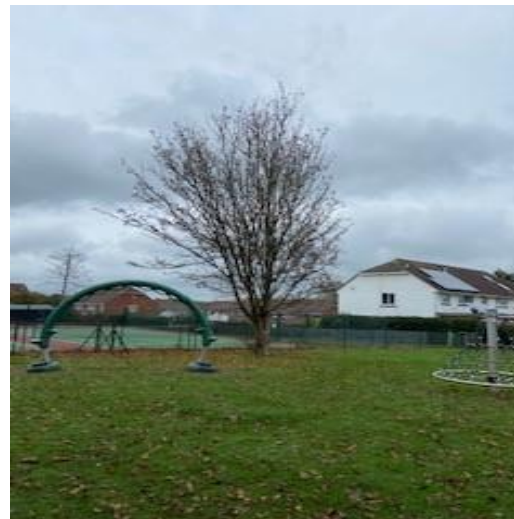
T2	Ornamental Fruit	M	<p>Tree splits at 0.3m from ground level in to distorted twisting of four main limbs, rubbing against each other causing weakness. Positioned by red rubbish bin. Crown Spread: N 3m, E 2m, S 1.5m, W 3m Deadwood present within crown. Tree shows a propensity to form tight unions although none are showing signs of bark inclusion at time of inspection. Base appears sound no sign of hollowing. Little nesting or roosting habitat value. Density and size of leafing – good. No cankers or fruiting bodies observed 2023 - No change - rot continues but no risk increase.</p>

<p>3.5m 40 mm</p>	<p>Recommend reducing to 2 m, crown clean to a neat shape to avoid eye/scratch injury to those using the adjacent bin.</p> <p>Consider removal.</p> <p>Recommend annual inspection if retained.</p> <p>2021 – no action since last year – recommendation remains the same. 2022 No change - rot on wound is deepening into main stem.</p> <p>2025 – removed.</p>

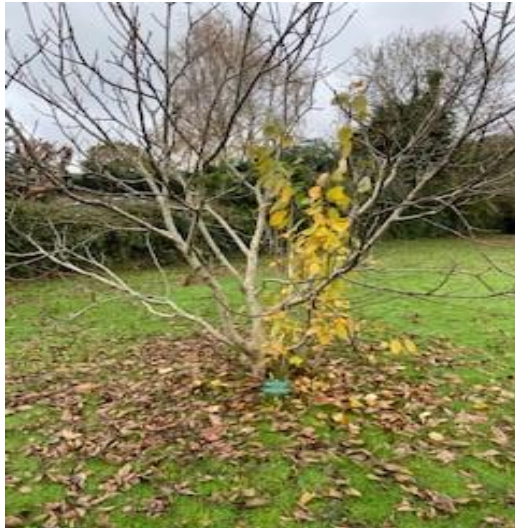
T3	Field Maple	M	<p>Poorly formed tree with two major stems (at 1m) , with poor unions. Northern stem reaches towards the adjacent footpath. Crown Spread: N 2m, E 2m, S 2m, W 2m Old wounds have occluded well. Ground to the east of the main stem dips and puddles in wet weather.</p>	<p>7.5 m 300mm</p>	<p>This tree will eventually grow into failure. To retain the tree it is recommended that cyclical reductions are carried out. Epicormic growth indicative of stress.</p> <p>Tree is used for climbing. Check regularly to ensure any snapped limbs from climbing are tidied to prevent infection.</p>

<p>2023</p>		<p>Monitor annually</p> <p>2021 – no action taken since 2020.</p> <p>Benefitted from a wetter year, with an improved leaf density and vigour. Slight mechanical damage to northern side of main stem - request that maintenance teams are aware to prevent worsening.</p> <p>2022 – No alterations.</p> <p>2023 – No changes</p> <p>2025 – No change</p>
T4	Walnut	2009 y	<p>Planted in memory of Ann Norris. Splits at ground level (40cm) into five main stems. Heavy epicormic growth around the base of the tree indicative of a tree struggling to produce enough foliage for adequate photosynthesis. Good budding. Some snapped twigs</p>

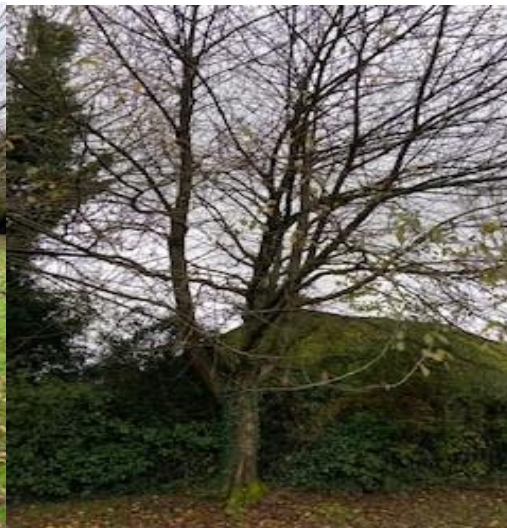
T4 Walnut

<p>2022</p>	<p>3m</p> <p>90 mm</p>	<p>Poor specimen growing in wet conditions, ideally Walnuts prefer a sandy soil that is free draining – we would suggest that the poor specimen is struggling in this position.</p> <p>However, it is valued and hopefully it will survive.</p> <p>2021 – this tree has also benefitted from a wetter year - improved leaf size, density and vigour.</p> <p>2022 – No alterations</p> <p>2023 - No changes</p> <p>2025 – Budding well – appears to be being used as a climbing frame due to low branching points which could cause damage.</p>

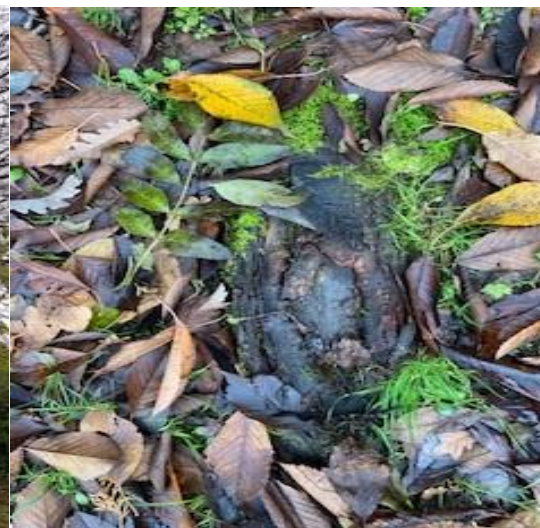
2023		
T5	Cherry	M	<p>Within hedgerow on eastern side of the playground. There is a wooden fence and then brick building on the far side of the hedgerow. Limbs have been put back on that side.</p> <p>Single stem to 2.7 m.</p> <p>Heavy ivy cover to main stem - removed where possible.</p> <p>Exposed damaged roots in grassed area of playground. Impossible to access far side of the main stem.</p> <p>2023 Ivy is beginning to encroach up the main stem again – sever now before it becomes a major issue. Weakness – main stem and first lateral evident – monitor.</p>

2023	10.5 m 850 mm	<p>Damaged roots can allow access for pathogens.</p> <p>Reduce the weight carried by limbs reaching over the playground.</p> <p>Sever ivy growth at base of tree and remove when it dies back.</p> <p>Instruct ground contractors to lift mower height to avoid root damage.</p> <p>2021</p> <p>No new root damage from mechanical mowers. More deadwood in the lower canopy that should be removed.</p> <p>2022 – cut limbs are on the ground around the base of the tree – trip hazards. Severed ivy is beginning to re-establish itself - cut again. Author pulled away substantial ivy cover.</p> <p>2025 – ivy has been pulled away and is largely dead - wound on ground to exposed roots – ask gardeners to lift blades on mowers.</p>

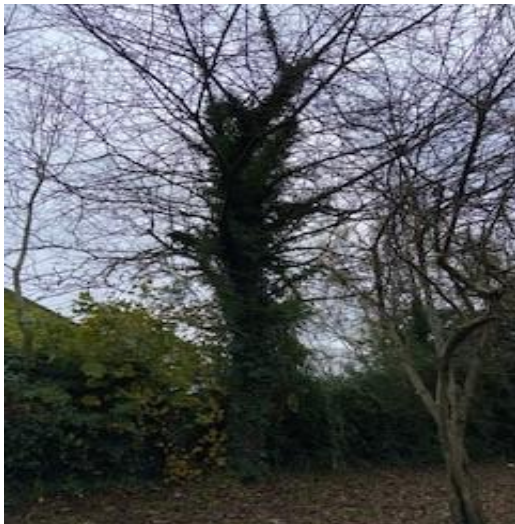
T5 Cherry – damaged roots in grass area

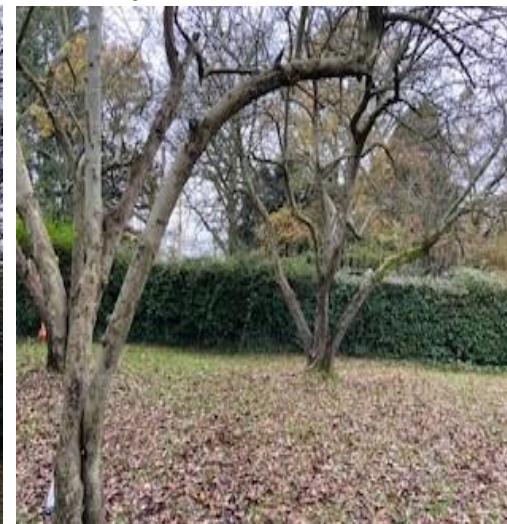
2023
T6	Cherry	M	<p>Ivy cover on main stem too strong to remove by hand.</p> <p>Heavy limb to east over neighbouring property – corner of the building approximately 2 m away.</p> <p>Deadwood in canopy. Exposed damaged roots in playground.</p> <div>

2023 </div>	10 m 700 mm	<p>Approach neighbours to suggest cutting limb back to avoid damage to their property.</p> <p>Remove deadwood.</p> <p>Instruct ground contractors to lift mower height to avoid root damage.</p> <p>2021 No new root damage Limbs that were touching adjacent building have been cut back.</p> <p>2022 Limbs have been cut back to property to rear. Ivy beginning to re-establish itself. Keep tackling ivy cover.</p> <p>2023 -excellent crown reduction, redressing crown imbalance.</p> <p>2025 - Extension to adjacent property to rear of the two cherries – canopies of the two trees will have to be regularly cut back to prevent damage to roofs.</p>

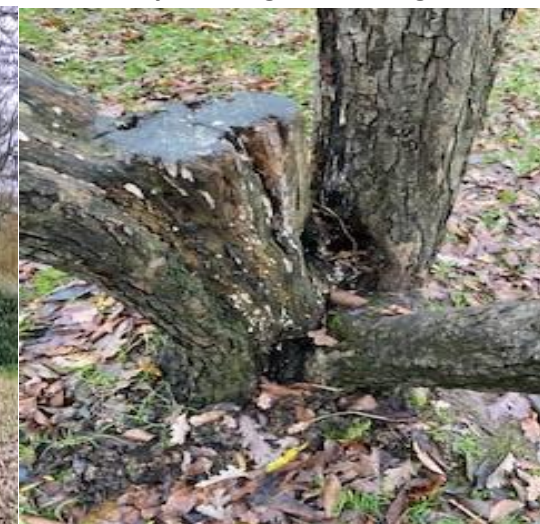
T7 8 and 9

T7 T8 T9	Group of three Ornamental	M	Positioned in the south-eastern corner of the playground. All split into three or four main stems, many exhibiting peeling bark	5 m average	Remove deadwood and monitor stability as they die back.

fruits		<p>and heavy deadwood. Fallen rotten fruit may be an issue in the late summer attracting wasps – assumption only. Ground levels and conditions good. 2023 – No change: 2025 – No change</p>

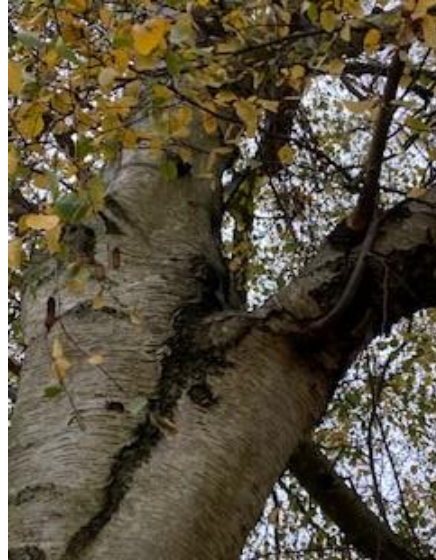
<p>2022 New bonfire area seems to have been established in the corner – prevent scorching of limbs. Cut limbs lying on the ground – trip hazards.</p>
T10	Silver Birch	M	<p>On western boundary of the playground. Crown spread: N 7m E 2m S 4 m W 6m Uneven crown shape – limbs to west hang over the hedge and pavement beyond and heavy limbs to the north. Damage to buttress roots on south-western side. Thin small leafing in the upper canopy.</p> <p>2021 – Evidence of area of decay on the northern side of the main stem, and mechanical damage. Thin canopy within the upper crown</p>	<p>9 m 440 mm</p>	<p>Consider reducing the height of the tree as it appears to be struggling to sustain the upper canopy. Even canopy up to match southern reaching limbs. Northern lower two limbs have a poor junction points, exhibiting weep marks where there appears to be a water retention point. Weight should be reduced.</p> <p>Lift over external pavement</p> <p>2021 – reduce canopy by 30%</p>

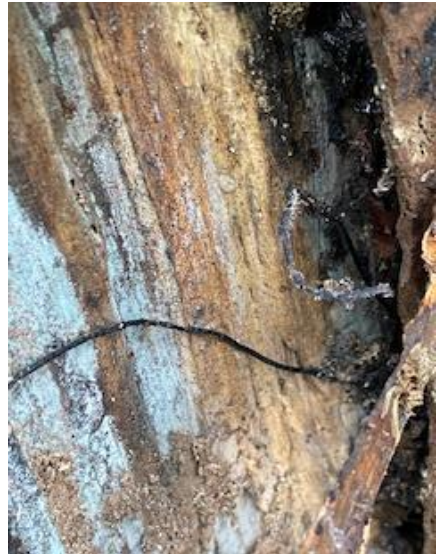
<p>2023</p>		<p>of canopy. Poor healing on cuts. One limb now reaches ground level - cut back so not accessible as climbing aid.</p> <p>2025 - No change.</p>
T11	Cherry	S-M	<p>Heavy ivy cover to main stem. The majority of the crown spreads to the west, over the hedge and pavement beyond. Ivy cover was removed, to find hollowed out stem with peeling bark. On the northern side of the main stem, evidence of honey fungus strands were identified. Crown spread is only to the west by 3 m</p>	<p>6.5 m</p> <p>440 mm</p>	<p>Recommend removal.</p> <p>2021 – remove. Honey fungus has progressed – main stem is much weaker.</p>

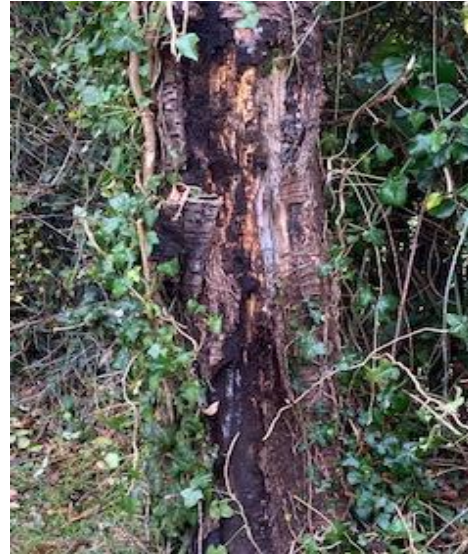
T11 Cherry – honey fungus strand

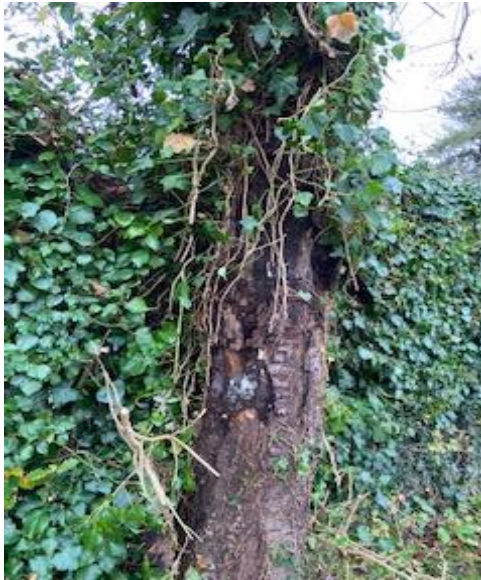
T11 Cherry – peeling bark

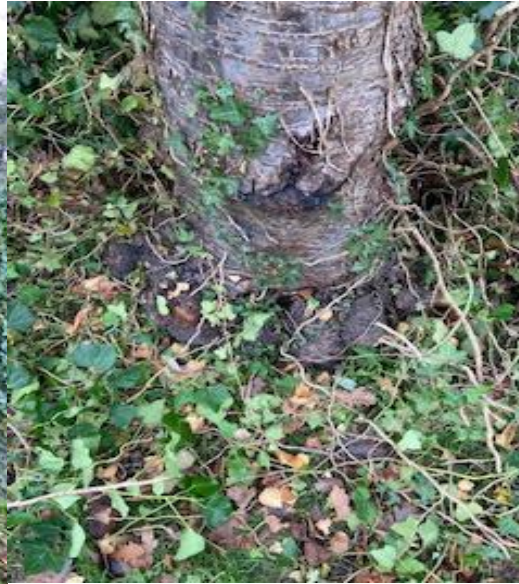
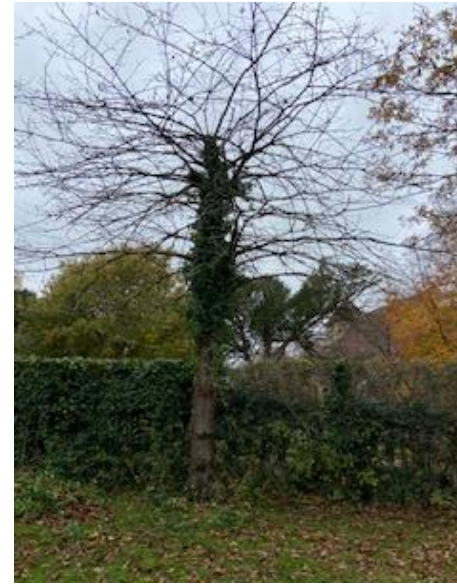
2023 – has been removed
T12	Cherry	S-M	<p>Heavy ivy cover on main stem. The majority of the crown spreads to the west as with T11. Crown spread to west 2.5m. Damaged exposed roots in grassed area of play areas observed.</p> <p>2023 - Has been removed.</p>	<p>6.0 m</p> <p>440 mm</p>	<p>Recommend removal.</p> <p>2021 – remove.</p>

<p>2022 – recommend removal. Bark is peeling away from limbs and main stem – extensive decay within main stem. Author removed some ivy cover.</p>
T13	Cherry	S-M	<p>Smaller specimen than T 11 and T12, and has a more even crown, spreading approximately 2 m in each direction. Damage to bark on main stem in places</p> <p>2023 – has been removed.</p>	<p>5.5 m</p> <p>300 mm</p>	<p>Monitor closely – proximity to T11 and T12 will make it vulnerable to honey fungus as root systems will be co-dependant.</p> <p>2021 – no action taken, much deadwood on the eastern side towards play equipment. Recommend removing deadwood, indicative of impaired feeding system.</p> <p>2022 – better specimen of the three - leader stem has been removed at some point – poor canopy shape. Remove and plant three trees that are not vulnerable to honey fungus in a line inside the hedgerow.</p>

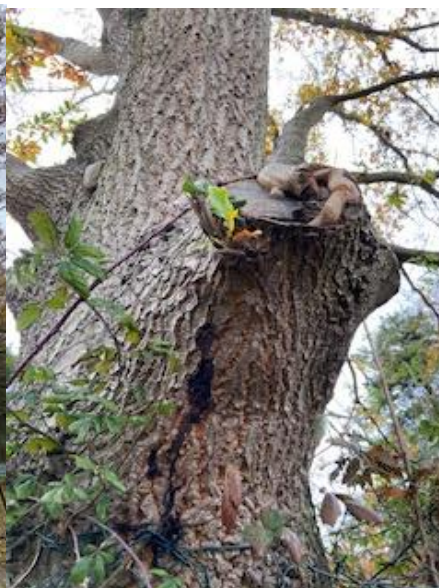
T14 Oak – poor occlusion

<p>Remove dead lateral to the north - high target zone to the roadside with bus stop and bench.</p> <p>2025 - some deadwood has been removed from the crown and cutting points exhibit good compartmentalisation. Monitor the joint in photo to left.</p>

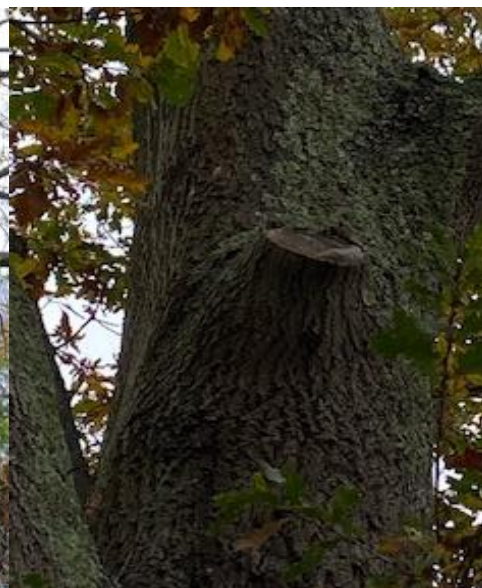
T14 Oak – poor healing ability

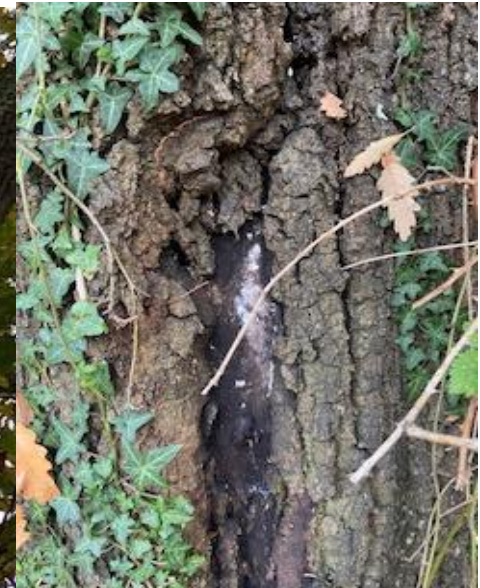
T14 Oak – basal wound (west)

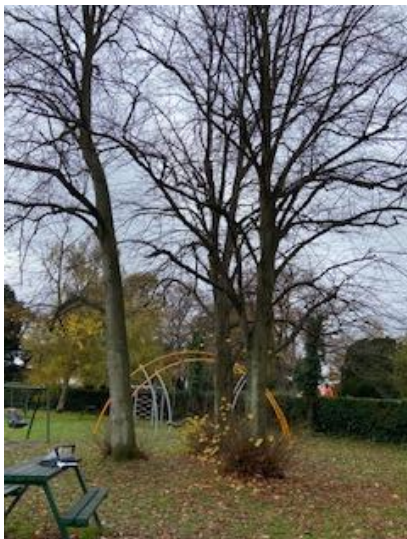
T15 Cherry by gate.

T15	Cherry – (By	M	<p>Crown Spread: N 5 m E 5.5 m</p>	7.5 m	Ask contractors to keep mower blades higher over the root system.

the gate)		<p>S 5 m W 4.5 m</p> <p>Target area high risk due to gateway to the play area. Tarmac areas to the west and north of the main stem.</p> <p>Damaged root system observed in grassed areas.</p> <p>Good sound mature specimen.</p> <p>2023 sever ivy growth which is covering most of the trunk and main limbs potentially hiding any cavities/defects.</p>

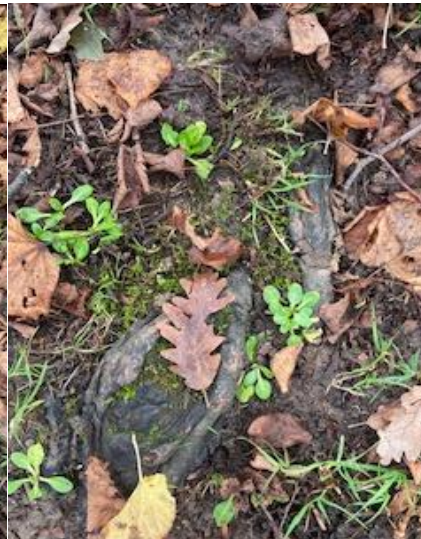
T16 Lime – root damage

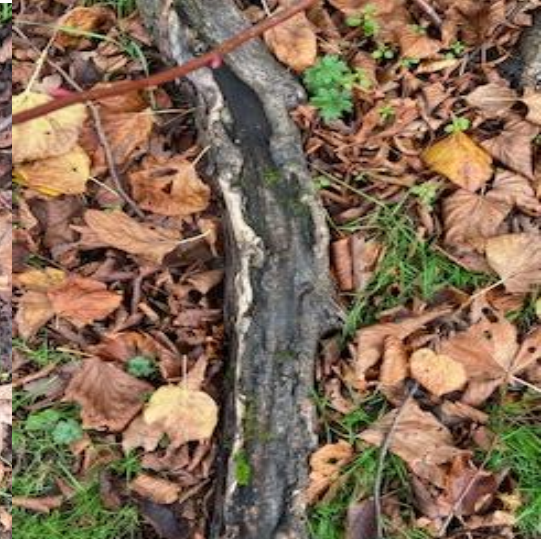
Damage to roots evident in the ground.

T17 Lime – root damage

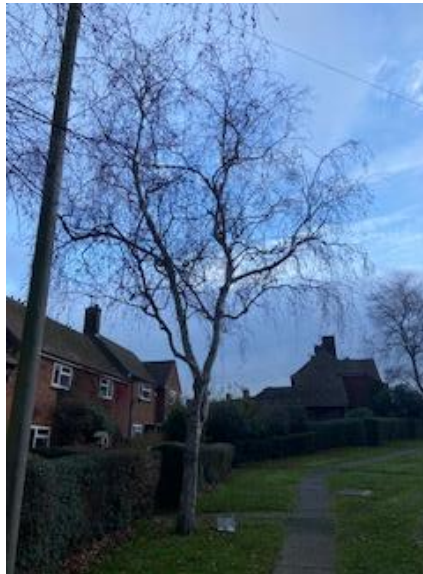
T19 Silver Birch – root damage

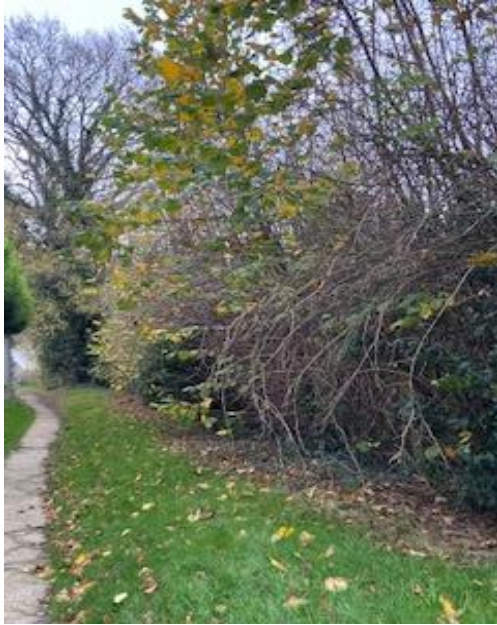
T20 Silver Birch – weak junction

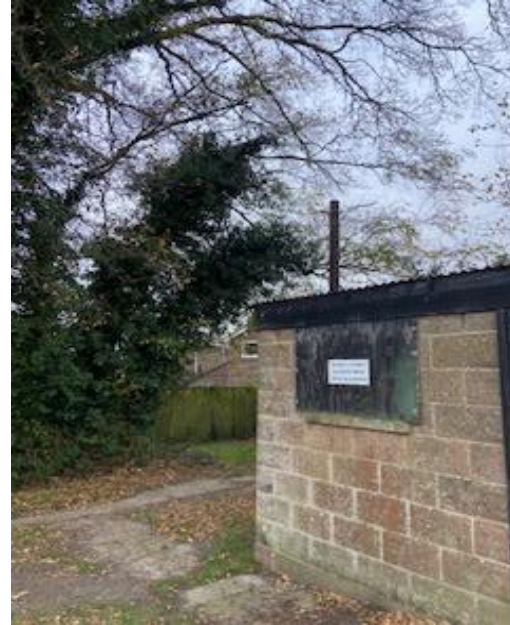
G1 - Mixed hedge

G1	Hedge	M	<p>Access to football field from Cottage Lane. Hedge lies to the south of the access route path.</p> <p>Mixture of Hazel, Holly, Rosehip and Field Maple.</p> <p>Panel fencing to adjoining gardens to the south.</p>

2022   2023	<p>35 m length</p> <p>Av height 4m</p>	<p>Suggest consulting with neighbouring gardens before cutting height of hedge back to 1.5 m which will thicken the hedgerow and improve wildlife habitat for nesting birds.</p> <p>Cut back Rosehips which reach path and could snag clothing or individuals.</p> <p>2021 G1 – Hedge is in the process of being laid – excellent use of the mixed hedge line. Specimen standard trees being left within the hedge line.</p> <p>2022 – excellent re-growth – fine example of good hedge-laying.</p> <p>2023 – hedge has flourished in the last 11 months - needs a top cut before bird nesting season.</p> <p>2025 – Hedge needs topping before nesting season to retain density of the hedgeline.</p>

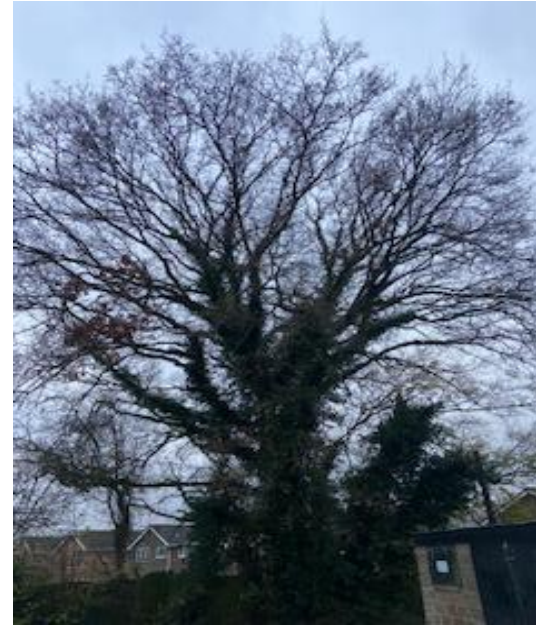
T21	Silver Birch	Veteran	<p>The tree splits into three main stems at 0.5m exerting pressure on the low junction point. Ivy cover is so dense, it is currently impossible to assess the tree properly.</p> <p>Ground in the area has been built up, possibly spoil arisen during construction of concrete pathway?</p> <p>Lawn mowing cuttings have been dumped to the south of the main stem.</p> <p>Uneven crown shape due to the dominant oak immediately to the east.</p> <p>Crown spread: N 1m E 1m S 6 m W 8.5m</p> <p>Good for wildlife habitat.</p> <p>2023 - dead ivy pulled away has revealed weak base with cavities near ground level – consider removal.</p>

<p>2023</p> <p>2025 - Has been removed.</p>	<p>8 m</p> <p>440 mm</p>	<p>Sever ivy and pull off once dead.</p> <p>Prevent further grass clippings being left in the area – causing unnatural ground level and acidic soil quality.</p> <p>With ivy removed, assessment in 2021 should be more informative.</p> <p>Cut back length of limbs over neighbouring garden to the south and remove deadwood.</p> <p>2021 – full inspection was not possible due to the excessive amount of ivy and dumped material to the rear of the tree. No work has been carried out.</p> <p>2022 Severed ivy is now dead - pull away from main stem. Area has not been cleared and more debris tipped to rear of main stem. Feathering at base is indicative of distress due to root compaction in the root protection zone. Clear the area.</p>

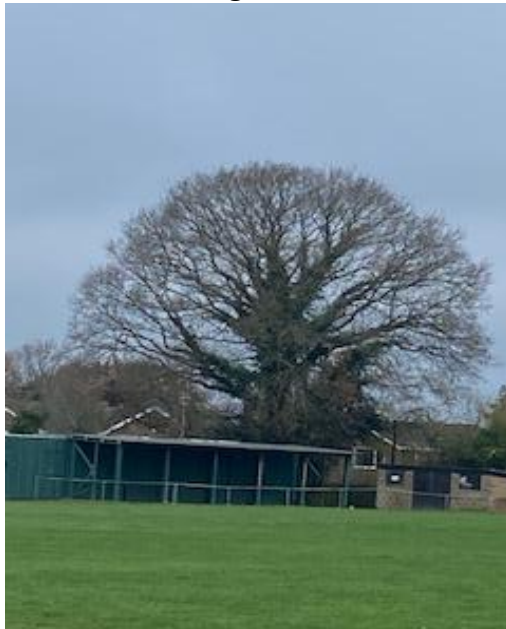
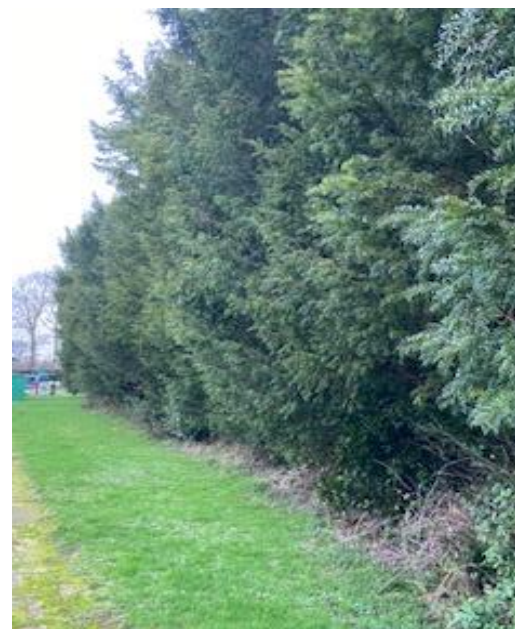
T22	Oak	Veteran	<p>This specimen is the dominant tree of the football field suppressing Silver Birch T21 to the west.</p> <p>Heavy ivy domination preventing access to inspect main stem</p> <p>Deadwood and damaged limbs within the</p>	<p>13 m</p> <p>1200 mm</p>	<p>Sever ivy.</p> <p>Cut back limbs over neighbouring garden, many of which have substantial deadwood within them.</p> <p>Remove holly stem to rear that prevents access to main stem.</p>

<p>canopy – up to 20%. Some epicormic growth on main stem, an indicator of stress. Unnatural ground level. Good canopy shape and budding points. Crown spread: N 11m E 9 m S 8 m W 10 m over the top of the adjacent Silver Birch.</p>

<p>2025 – good reduction Consider 5 year cycle to reduce back over neighbouring gardens.</p>	<p>Recommend climbing inspection whilst removing dead and broken limbs. 2021 Cavity at base on northern side – with rubbish inserted which made measuring the extent of the cavity depth impossible. Area around the veteran tree should be cleared to allow for full inspection - high risk area – <u>remove adjacent dying Hawthorn in the process.</u> 2022 – Silver Birch is still being adversely affected by the Oak’s canopy. Limbs are touching cable running to the aerial on the pavilion - cut back. Hanging broken limb on northern side of the canopy should be removed. Debris continues to be dumped to rear of the main stem. Low limbs to the east over the path should be lifted.</p>
