Tree Survey: Trees in Westfield Village.

Client: Westfield Parish Council.

Date: January 2025

Surveyors and Report Authors: F. Nowne BA (Hons.)

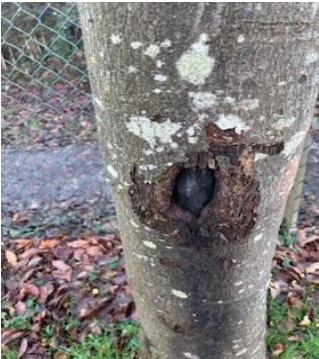
Tree	Species	Life Stage	Condition	Height & Dbh	Comments
T1	Crab Apple	M	<p>Well balanced crown, starting to exhibit veteran features. Height to lowest part of canopy = 1.8m. Open unions, no tight forks.</p> <p>Crown spread: N 2 m, E 2 m, S 2.5 m, W 2 m.</p> <p>Multi-stemmed from 2m exhibiting tight junction points and some in-growing limbs.</p> <p>Good ground conditions on observation</p> <p>Minor mechanical damage to southern side of main stem.</p> <p>Some honey fungus growth at the base of the stem.</p> <p>2021 – wound on main stem exhibits further decay – fruiting body of honey fungus on the ground within the root zone area. Cyclical reduction recommended in 2020 not carried out to date. Consider reduction.</p> <p>2023 – wound to main stem is struggling to heal. Consider reducing crown by 30%.</p>

<p>7 m</p> <p>270 mm</p>	<p>Footpath to the north – soil levels have been altered in the past.</p> <p>Recommend remove of small amount of deadwood within the canopy over target areas.</p> <p>Due to amenity area recommend cyclical reduction plan, to maintain at current size – within five years carry out light sympathetic reduction to BS 3998.</p> <p>Monitor fungal growth each year.</p> <p>Provides good nesting and roosting habitat.</p>

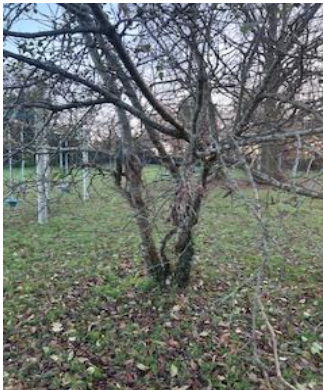
T2	Ornamental Fruit	M	<p>Tree splits at 0.3m from ground level in to distorted twisting of four main limbs, rubbing against each other causing weakness. Positioned by red rubbish bin. Crown Spread: N 3m, E 2m, S 1.5m, W 3m Deadwood present within crown. Tree shows a propensity to form tight unions although none are showing signs of bark inclusion at time of inspection. Base appears sound no sign of hollowing. Little nesting or roosting habitat value. Density and size of leafing – good. No cankers or fruiting bodies observed 2023 - No change - rot continues but no risk increase.</p>

<p>3.5m 40 mm</p>	<p>Recommend reducing to 2 m, crown clean to a neat shape to avoid eye/scratch injury to those using the adjacent bin.</p> <p>Consider removal.</p> <p>Recommend annual inspection if retained.</p> <p>2021 – no action since last year – recommendation remains the same. 2022 No change - rot on wound is deepening into main stem.</p> <p>2025 – removed.</p>

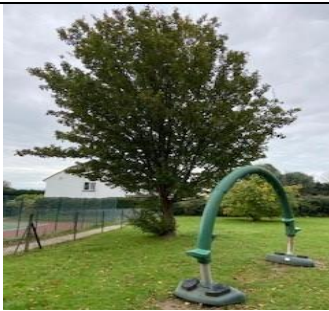
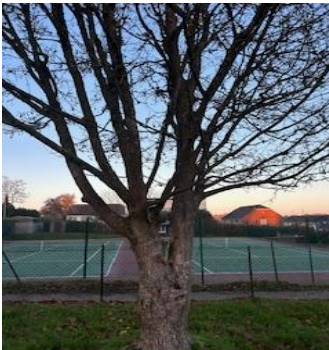
T3	Field Maple	M	<p>Poorly formed tree with two major stems (at 1m) , with poor unions. Northern stem reaches towards the adjacent footpath. Crown Spread: N 2m, E 2m, S 2m, W 2m Old wounds have occluded well. Ground to the east of the main stem dips and puddles in wet weather.</p>	<p>7.5 m 300mm</p>	<p>This tree will eventually grow into failure. To retain the tree it is recommended that cyclical reductions are carried out. Epicormic growth indicative of stress.</p> <p>Tree is used for climbing. Check regularly to ensure any snapped limbs from climbing are tidied to prevent infection.</p>

<p>2023</p>		<p>Monitor annually</p> <p>2021 – no action taken since 2020.</p> <p>Benefitted from a wetter year, with an improved leaf density and vigour. Slight mechanical damage to northern side of main stem - request that maintenance teams are aware to prevent worsening.</p> <p>2022 – No alterations.</p> <p>2023 – No changes</p> <p>2025 – No change</p>
T4	Walnut	2009 y	<p>Planted in memory of Ann Norris. Splits at ground level (40cm) into five main stems. Heavy epicormic growth around the base of the tree indicative of a tree struggling to produce enough foliage for adequate photosynthesis. Good budding. Some snapped twigs</p>

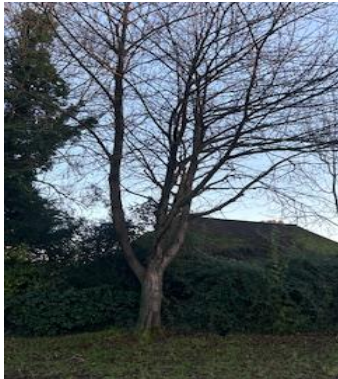
2023		
T5	Cherry	M	<p>Within hedgerow on eastern side of the playground. There is a wooden fence and then brick building on the far side of the hedgerow. Limbs have been put back on that side.</p> <p>Single stem to 2.7 m.</p> <p>Heavy ivy cover to main stem - removed where possible.</p> <p>Exposed damaged roots in grassed area of playground. Impossible to access far side of the main stem.</p> <p>2023 Ivy is beginning to encroach up the main stem again – sever now before it becomes a major issue. Weakness – main stem and first lateral evident – monitor.</p>

2023	10.5 m 850 mm	<p>Damaged roots can allow access for pathogens.</p> <p>Reduce the weight carried by limbs reaching over the playground.</p> <p>Sever ivy growth at base of tree and remove when it dies back.</p> <p>Instruct ground contractors to lift mower height to avoid root damage.</p> <p>2021</p> <p>No new root damage from mechanical mowers. More deadwood in the lower canopy that should be removed.</p> <p>2022 – cut limbs are on the ground around the base of the tree – trip hazards. Severed ivy is beginning to re-establish itself - cut again. Author pulled away substantial ivy cover.</p> <p>2025 – ivy has been pulled away and is largely dead - wound on ground to exposed roots – ask gardeners to lift blades on mowers.</p>

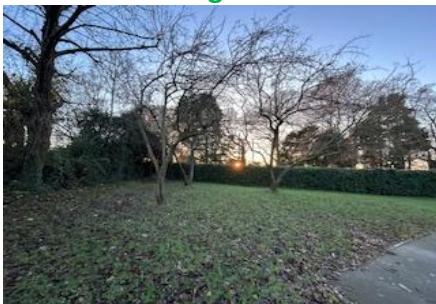
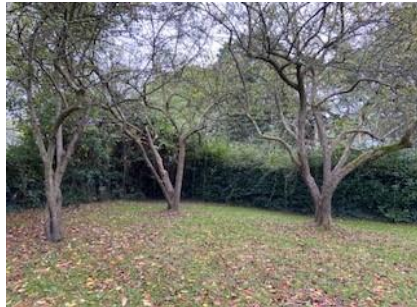
T7 T8 T9	Group of three Ornamental	M	Positioned in the south-eastern corner of the playground. All split into three or four main stems, many exhibiting peeling bark	5 m average	Remove deadwood and monitor stability as they die back.

fruits		<p>and heavy deadwood. Fallen rotten fruit may be an issue in the late summer attracting wasps – assumption only. Ground levels and conditions good. 2023 – No change: 2025 – No change</p>

<p>2023</p>	150 mm av	<p>2021 – Die-back has continued in all three – no action taken to date.</p>

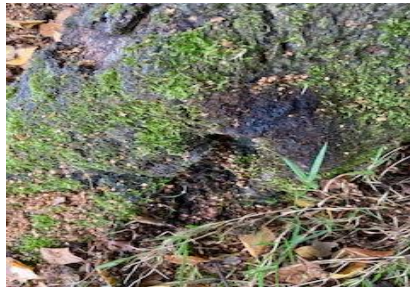
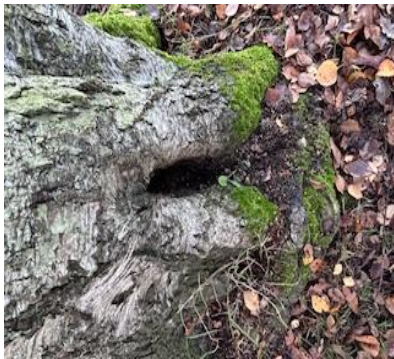
<p>2022 New bonfire area seems to have been established in the corner – prevent scorching of limbs. Cut limbs lying on the ground – trip hazards.</p>
T10	Silver Birch	M	<p>On western boundary of the playground. Crown spread: N 7m E 2m S 4 m W 6m Uneven crown shape – limbs to west hang over the hedge and pavement beyond and heavy limbs to the north. Damage to buttress roots on south-western side. Thin small leafing in the upper canopy.</p> <p>2021 – Evidence of area of decay on the northern side of the main stem, and mechanical damage. Thin canopy within the upper crown</p>	<p>9 m 440 mm</p>	<p>Consider reducing the height of the tree as it appears to be struggling to sustain the upper canopy. Even canopy up to match southern reaching limbs. Northern lower two limbs have a poor junction points, exhibiting weep marks where there appears to be a water retention point. Weight should be reduced.</p> <p>Lift over external pavement</p> <p>2021 – reduce canopy by 30%</p>

<p>2022 Lost limb observed on southern side</p>

<p>2023 – Wound observed at base – good crown balance -monitor</p>

<p>2023</p>		<p>of canopy. Poor healing on cuts. One limb now reaches ground level - cut back so not accessible as climbing aid.</p> <p>2025 - No change.</p>
T11	Cherry	S-M	<p>Heavy ivy cover to main stem. The majority of the crown spreads to the west, over the hedge and pavement beyond. Ivy cover was removed, to find hollowed out stem with peeling bark. On the northern side of the main stem, evidence of honey fungus strands were identified. Crown spread is only to the west by 3 m</p>	<p>6.5 m</p> <p>440 mm</p>	<p>Recommend removal.</p> <p>2021 – remove. Honey fungus has progressed – main stem is much weaker.</p>

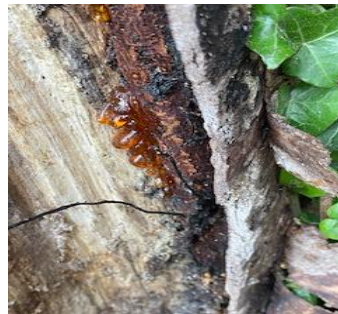
<p>2022 no action taken – remove</p>

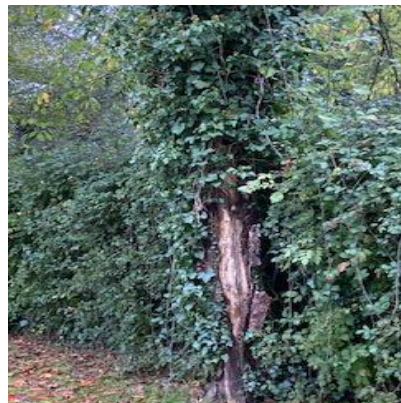
2023 – has been removed
T12	Cherry	S-M	<p>Heavy ivy cover on main stem. The majority of the crown spreads to the west as with T11. Crown spread to west 2.5m. Damaged exposed roots in grassed area of play areas observed.</p> <p>2023 - Has been removed.</p>	<p>6.0 m</p> <p>440 mm</p>	<p>Recommend removal.</p> <p>2021 – remove.</p>

<p>2022 – recommend removal. Bark is peeling away from limbs and main stem – extensive decay within main stem. Author removed some ivy cover.</p>
T13	Cherry	S-M	<p>Smaller specimen than T 11 and T12, and has a more even crown, spreading approximately 2 m in each direction. Damage to bark on main stem in places</p> <p>2023 – has been removed.</p>	<p>5.5 m</p> <p>300 mm</p>	<p>Monitor closely – proximity to T11 and T12 will make it vulnerable to honey fungus as root systems will be co-dependant.</p> <p>2021 – no action taken, much deadwood on the eastern side towards play equipment. Recommend removing deadwood, indicative of impaired feeding system.</p> <p>2022 – better specimen of the three - leader stem has been removed at some point – poor canopy shape. Remove and plant three trees that are not vulnerable to honey fungus in a line inside the hedgerow.</p>

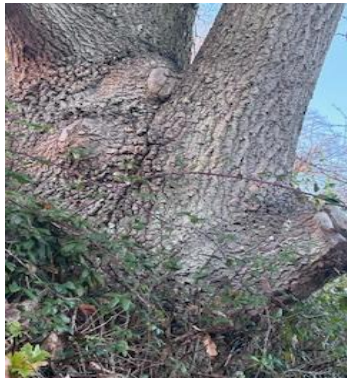
<p>Main stem splits at 3m. Crown spread: N 14 m E 12 m S 11 m W 12 m Good crown spread with dense leafing, although tips of canopy are thinner. Major limb running parallel with hedge to north is dead and should be removed. Target area = bus shelter and pavement Limb to south east is also dead.</p> <p>2021</p>

<p>Deadwood in canopy over playground – evidence of slow deterioration. Weep marks on main stem (see above)</p>

<p>2023 Weak joint occluded seam. Has ownership been ascertained? Monitor annually.</p>		<p>deadwood in upper northern canopy – ownership to be established (ESCC?). Tree is continuing to produce deadwood, indicating decline in health.</p> <p>Remove south-eastern limb.</p> <p>Remove deadwood in southern side of the canopy. 2021</p>

<p>Remove dead lateral to the north - high target zone to the roadside with bus stop and bench.</p> <p>2025 - some deadwood has been removed from the crown and cutting points exhibit good compartmentalisation. Monitor the joint in photo to left.</p>

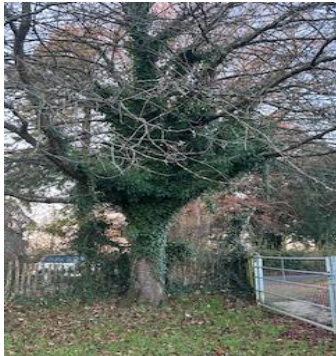
the gate)		<p>S 5 m W 4.5 m</p> <p>Target area high risk due to gateway to the play area. Tarmac areas to the west and north of the main stem.</p> <p>Damaged root system observed in grassed areas.</p> <p>Good sound mature specimen.</p> <p>2023 sever ivy growth which is covering most of the trunk and main limbs potentially hiding any cavities/defects.</p>

<p>2023</p>	590 mm	<p>2021 – sever ivy</p> <p>20 – 25% deadwood in canopy</p> <p>Canopy resting on bus stop road side - lift to avoid damage to the roof.</p> <p>No further ground damage observed.</p> <p>2022 Ivy cover has reached upper canopy and should be severed - cut limbs on the ground are a trip hazard – remove.</p> <p>2025 – The majority of the ivy has died back but is still live at the base - suggest severing it now. Tree is in good health.</p>
T16	Lime	M	<p>Positioned in the centre of the play area as one of a group of three, presenting as one canopy. All have damaged surface roots and suffer from ground compaction around the main stems. Canopies all spread to the outer sides of the grouping with little crown spread within the inner circle.</p> <p>Crown spread to the north 5 m.</p> <p>Small amount of deadwood - epicormic growth at base is normal in this species.</p> <p>2023 – Crown reduction and removal of epicormic growth has improved matters.</p>	<p>12.5 m</p> <p>580 mm</p>	<p>Remove deadwood and consider height reduction of 20 – 25% to reduce the risk of wind blow.</p> <p>Measures to avoid ground compaction and mechanical damage to main stems and above ground rooting material should be adopted.</p> <p>2021 – same recommendation - no significant changes.</p>

T15	Cherry – (By	M	<p>Crown Spread: N 5 m E 5.5 m</p>	7.5 m	Ask contractors to keep mower blades higher over the root system.

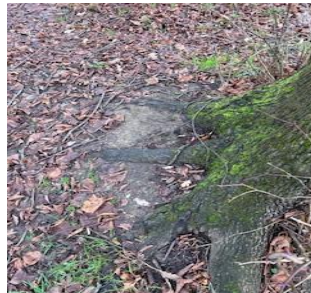
<p>3 x Limes 2022 - all exhibiting heavy feathering around the base, typical to Limes. Deadwood on ground represents a trip hazard.</p>
T17	Lime	M	<p>Positioned in the centre of the play area as one of a group of three, presenting as one canopy. All have damaged surface roots and suffer from ground compaction around the main stems. Canopies all spread to the outer sides of the grouping with little crown spread within the inner circle.</p> <p>Crown spread to east 5m</p> <p>Small amount of deadwood – epicormic growth at base is normal in this species.</p> <p>2023 – Crown reduction and removal of epicormic growth has improved matters.</p>	<p>12 m</p> <p>630 mm</p>	<p>Remove deadwood and consider height reduction of 20 – 25% to reduce the risk of wind blow.</p> <p>Measures to avoid ground compaction and mechanical damage to main stems and above ground rooting material should be adopted.</p> <p>2021 – same recommendation – no increase in deadwood.</p> <p>2022 Fallen deadwood on ground to remove. 2023 – no change</p> <p>2025 – remove deadwood and hangers from canopy</p>

Damage to roots evident in the ground.

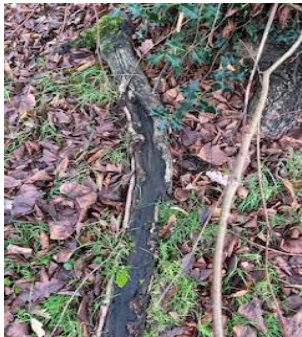
2023
T18	Lime	M	<p>Positioned in the centre of the play area as one of a group of three, presenting as one canopy. All have damaged surface roots and suffer from ground compaction around the main stems. Canopies all spread to the outer sides of the grouping with little crown spread within the inner circle.</p> <p>Crown spread to the west 5m.</p> <p>Mechanical damage to main stem.</p> <p>Small amount of deadwood - epicormic growth at base is normal in this species.</p> <p>2023 – Crown reduction and removal of epicormic growth has improved matters. Damage to roots evident in the ground.</p> <p>2025 – Remove deadwood and hangers</p>	<p>13 m</p> <p>510 cm</p>	<p>Remove deadwood and consider height reduction of 20 – 25% to reduce the risk of wind blow.</p> <p>Measures to avoid ground compaction and mechanical damage to main stems and above ground rooting material should be adopted.</p> <p>2021 – tight junctions.</p> <p>No deterioration in condition.</p>

2022 Heavy feathering and deadwood on ground - remove. 2023 – No change

<p>2023 – poor healing points and bark loss at cutting points on western side of the crown.</p>		
--	--	--	---	--	--

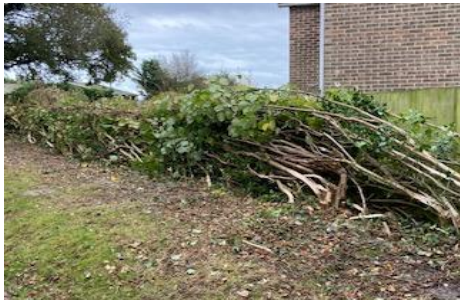
G1	Hedge	M	<p>Access to football field from Cottage Lane. Hedge lies to the south of the access route path.</p> <p>Mixture of Hazel, Holly, Rosehip and Field Maple.</p> <p>Panel fencing to adjoining gardens to the south.</p>

2022   2023	<p>35 m length</p> <p>Av height 4m</p>	<p>Suggest consulting with neighbouring gardens before cutting height of hedge back to 1.5 m which will thicken the hedgerow and improve wildlife habitat for nesting birds.</p> <p>Cut back Rosehips which reach path and could snag clothing or individuals.</p> <p>2021 G1 – Hedge is in the process of being laid – excellent use of the mixed hedge line. Specimen standard trees being left within the hedge line.</p> <p>2022 – excellent re-growth – fine example of good hedge-laying.</p> <p>2023 – hedge has flourished in the last 11 months - needs a top cut before bird nesting season.</p> <p>2025 – Hedge needs topping before nesting season to retain density of the hedgeline.</p>

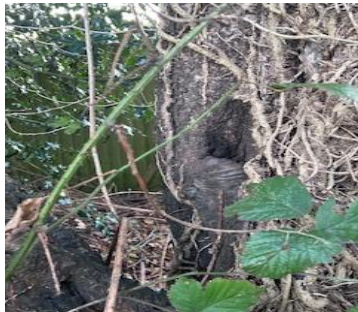
T21	Silver Birch	Veteran	<p>The tree splits into three main stems at 0.5m exerting pressure on the low junction point. Ivy cover is so dense, it is currently impossible to assess the tree properly.</p> <p>Ground in the area has been built up, possibly spoil arisen during construction of concrete pathway?</p> <p>Lawn mowing cuttings have been dumped to the south of the main stem.</p> <p>Uneven crown shape due to the dominant oak immediately to the east.</p> <p>Crown spread: N 1m E 1m S 6 m W 8.5m</p> <p>Good for wildlife habitat.</p> <p>2023 - dead ivy pulled away has revealed weak base with cavities near ground level – consider removal.</p>

<p>2023</p> <p>2025 - Has been removed.</p>	<p>8 m</p> <p>440 mm</p>	<p>Sever ivy and pull off once dead.</p> <p>Prevent further grass clippings being left in the area – causing unnatural ground level and acidic soil quality.</p> <p>With ivy removed, assessment in 2021 should be more informative.</p> <p>Cut back length of limbs over neighbouring garden to the south and remove deadwood.</p> <p>2021 – full inspection was not possible due to the excessive amount of ivy and dumped material to the rear of the tree. No work has been carried out.</p> <p>2022 Severed ivy is now dead - pull away from main stem. Area has not been cleared and more debris tipped to rear of main stem. Feathering at base is indicative of distress due to root compaction in the root protection zone. Clear the area.</p>

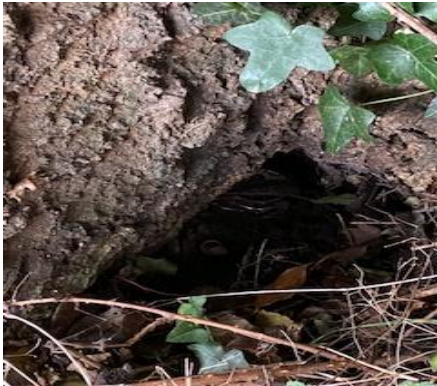
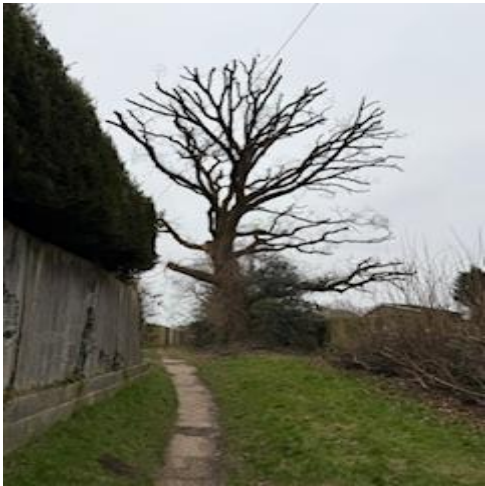
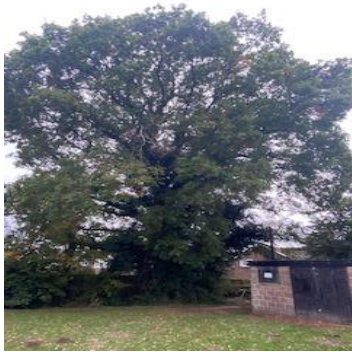
T22	Oak	Veteran	<p>This specimen is the dominant tree of the football field suppressing Silver Birch T21 to the west.</p> <p>Heavy ivy domination preventing access to inspect main stem</p> <p>Deadwood and damaged limbs within the</p>	<p>13 m</p> <p>1200 mm</p>	<p>Sever ivy.</p> <p>Cut back limbs over neighbouring garden, many of which have substantial deadwood within them.</p> <p>Remove holly stem to rear that prevents access to main stem.</p>

<p>canopy – up to 20%. Some epicormic growth on main stem, an indicator of stress. Unnatural ground level. Good canopy shape and budding points. Crown spread: N 11m E 9 m S 8 m W 10 m over the top of the adjacent Silver Birch.</p>

<p>2025 – good reduction Consider 5 year cycle to reduce back over neighbouring gardens.</p>	<p>Recommend climbing inspection whilst removing dead and broken limbs. 2021 Cavity at base on northern side – with rubbish inserted which made measuring the extent of the cavity depth impossible. Area around the veteran tree should be cleared to allow for full inspection - high risk area – <u>remove adjacent dying Hawthorn in the process.</u> 2022 – Silver Birch is still being adversely affected by the Oak’s canopy. Limbs are touching cable running to the aerial on the pavilion - cut back. Hanging broken limb on northern side of the canopy should be removed. Debris continues to be dumped to rear of the main stem. Low limbs to the east over the path should be lifted.</p>

<p>2023 - Part of the crown broke away in recent storms and has been made safe.</p> <p>Whole crown reduction is necessary to tidy wounds and minimise potential infection and water intake and therefore create a</p>

2023		<p>smaller crown, less vulnerable to wind blow.</p> <p>Scheduled for new year.</p>
G2	Yew hedgerow	M	<p>55 m row of Yew trees.</p> <p>2021 Work has been completed.</p> <p>2023 – No change.</p> <p>2025 – Hedge has thickened into a good dense hedge line - keep it topped to retain the density.</p>		<p>It is understood that it has been arranged to reduce the height and width of the row, and then maintain them as a boundary hedge as intended at planting.</p> <p>2022 Trees are recovering well and bushing out effectively as a good hedge line. Good management to boundary line.</p>

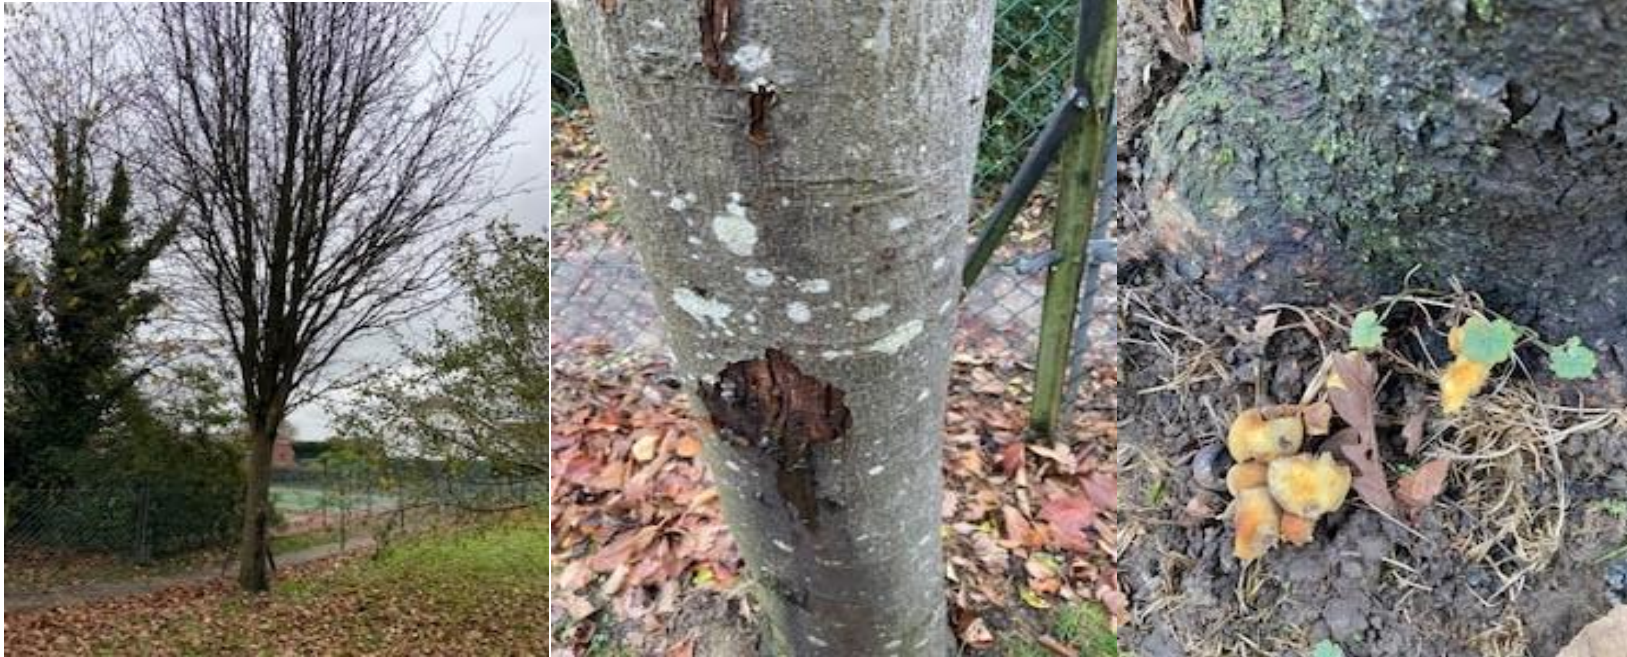
T1 Mechanical damage at base and fruiting bodies – Crab Apple

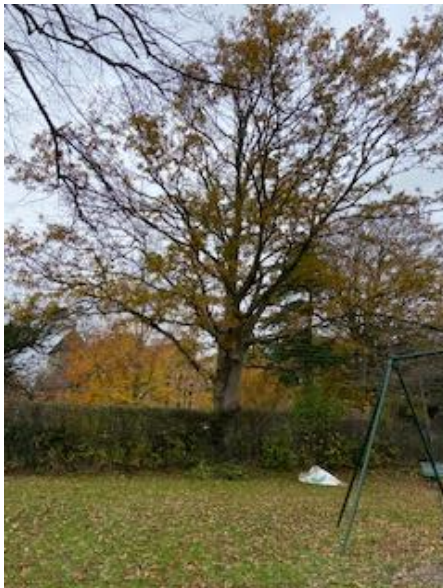
T14 Oak – poor occlusion

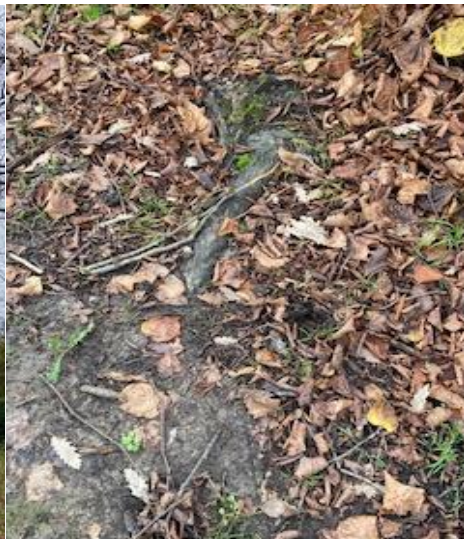
T16 Lime – root damage

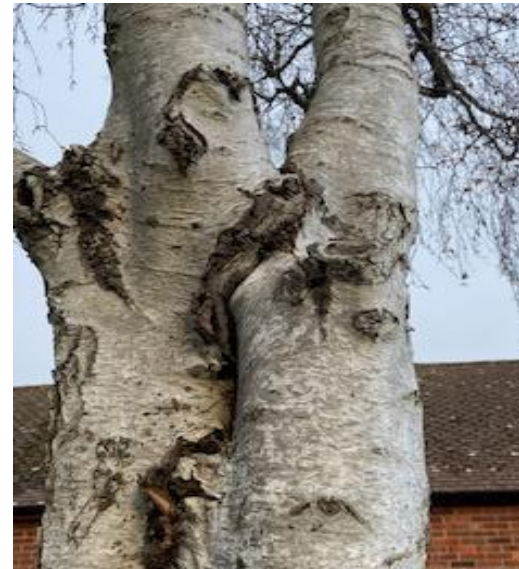
T20 Silver Birch – weak junction
